Lack of Fall Protection Measures Place Workers at Increased Risk

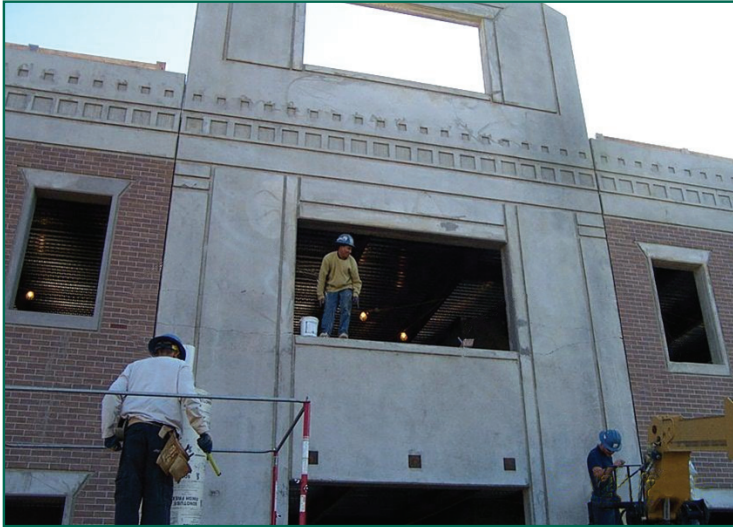
A construction company president received this picture in an email from his customer inquiring about the look of a wall on a new office building.

The employee on the left of the picture is standing on scaffolding erecting a concrete pillar form. The scaffold is almost 20 feet tall, exceeds the 4:1 height to base ratio, and is not restrained. In addition, there are no midrails or ladder access for this worker. This scaffold was not erected or inspected by a competent person.

An employee (center of picture) is standing on the 3rd floor of a building with no guard rails in place or other fall protection. Note that his toes are over the edge and he is leaning outside the building.

On the right side of the picture is a forklift picking up two people (only one visible in this picture) on a pallet. The forklift is sitting on a berm embankment to gain access to the higher parts of the structure. The operator is the site superintendent. The one visible person on the pallet is not an employee, but the superintendent's 16-year-old son. They were cleaning the wall of excess material.

The worker on the scaffolding could have fallen from the scaffold, which had no safe access and inadequate guard railing. In addition, the scaffold itself exceeded the allowable 4:1 height to base ratio without restraint and ran the risk of tipping over.

The worker leaning out the 3rd floor window could have fallen over 20 feet to a hard-packed dirt surface. This worker had previously broken his arm, sued the company because of his injury, and won a judgment against the company.

The two people on the pallet could have fallen or been thrown from the forklift when it was moving or extending to position the people closer to the wall.

Supported scaffolds with a height to base width (including outrigger supports, if used) ratio of more than four to one (4:1) shall be restrained from tipping by guying, tying, bracing, or equivalent means ... Guys, ties, and braces shall be installed according to the scaffold manufacturer's recommendations.

According to OSHA standards, no scaffold shall be erected, moved, altered or dismantled unless under the supervision and direction of a competent person. A scaffold must also be inspected by a competent person before each work shift for defects or more often if you suspect any damage from wind, overloading or equipment contact. Employees shall have safe access at all working levels.

Any construction worker who is exposed to a fall greater than six feet must have some kind of fall protection; a guard rail system, safety net system, or a personal fall arrest system.

The workers on the pallet were exposed to a fall, and you should NEVER lift someone up on the forks of a lift truck unless they are in a properly designed personnel basket on a lift that is rated for that purpose. Workers should consult the lift truck's operator manual and other factory documentation to determine if the lift truck is rated for hoisting personnel. If this information is not provided, a representative of the manufacturer should be consulted.

Using under age workers for construction work is a dangerous practice. The U.S. Department of Labor's Wage and Hour Division does not allow young workers to operate most equipment or to be employed in occupations that have been declared hazardous by the Secretary of Labor.
